**THE CALIFORNIA EARTHQUAKE OF APRIL 18, 1906**

**REPORT**

**OF THE**

ANDREW C. LAWSON

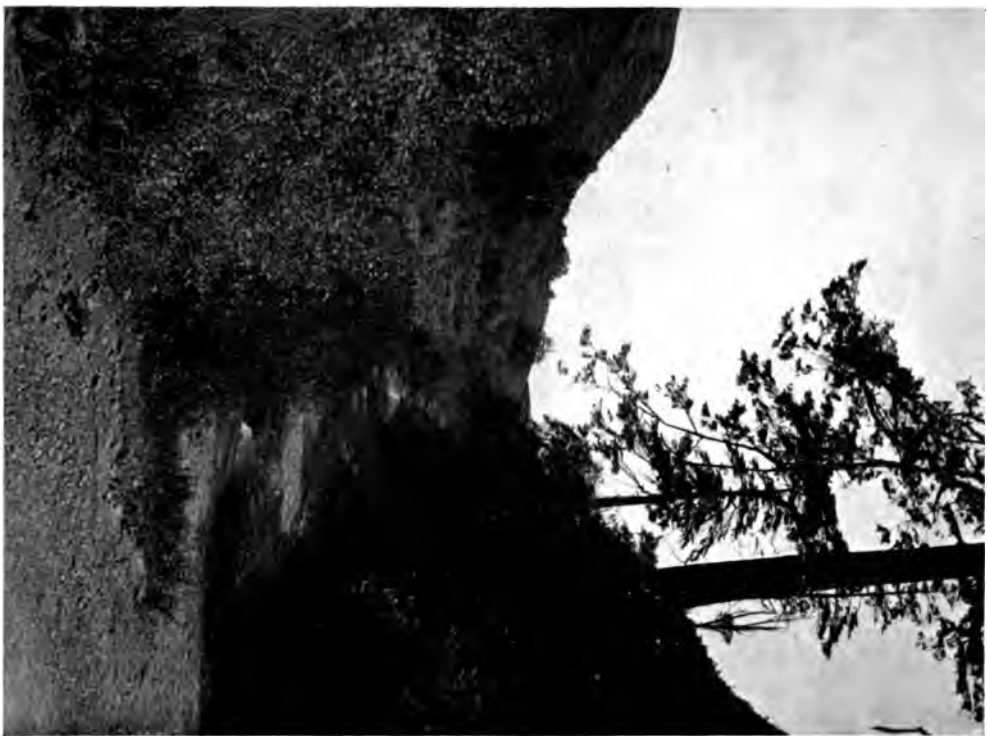
A. Wood Gulch, Humboldt County. The Rift near its northern end. A. S. E.

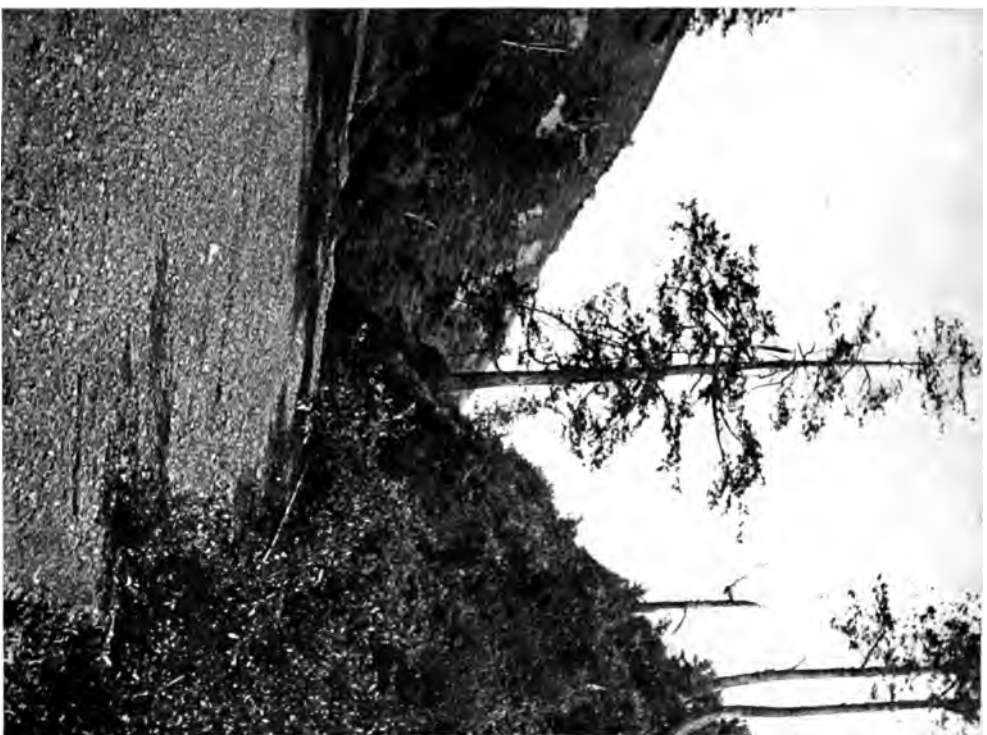
B. Another view of the Rift. Wood Gulch. A. S. E.

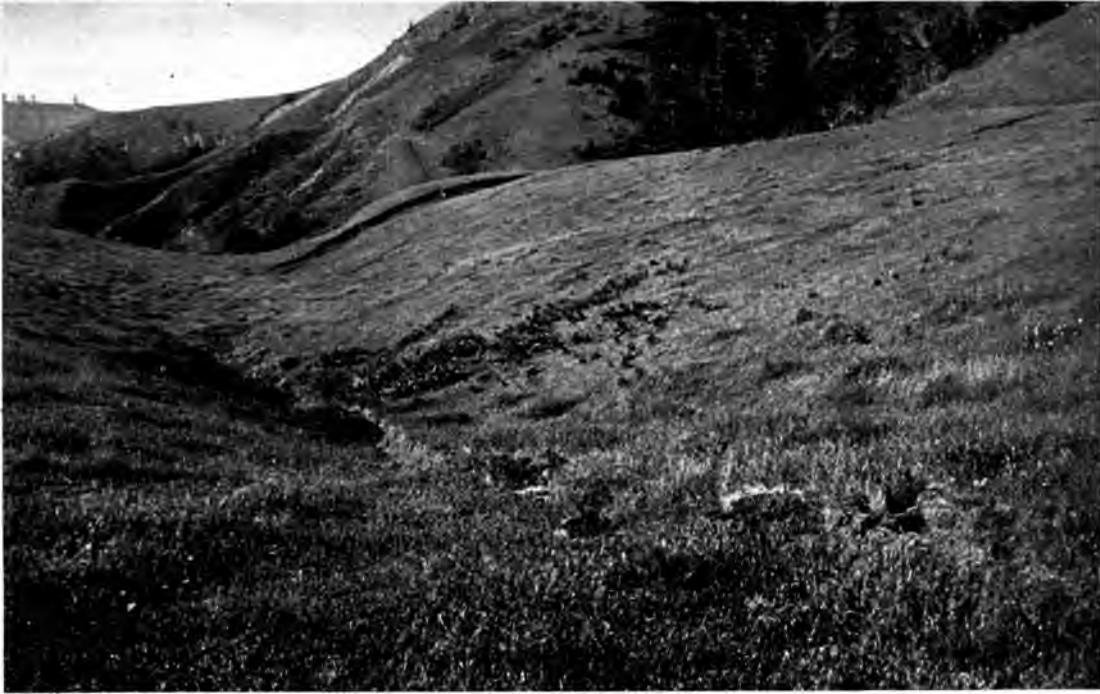
A. The Rift above Shelter Cove, Humboldt County. A. S. E.

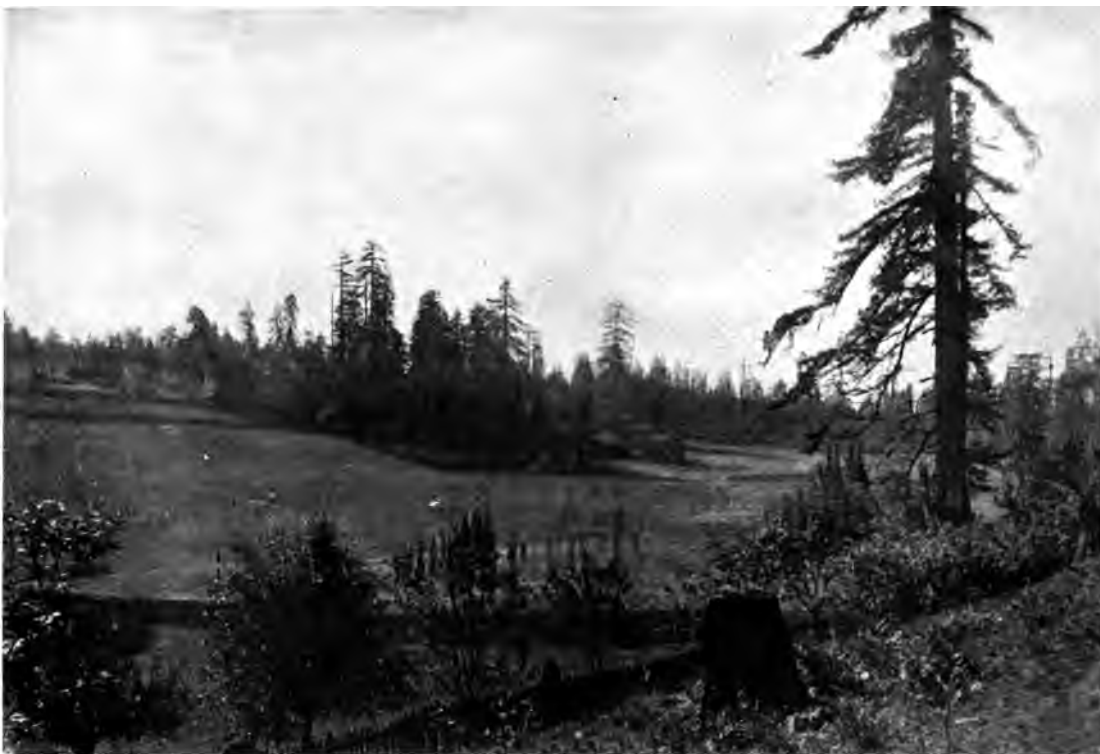
B. The Rift on the divide between the upper Gualala and the coast north of Fort Ross. H. W. F.

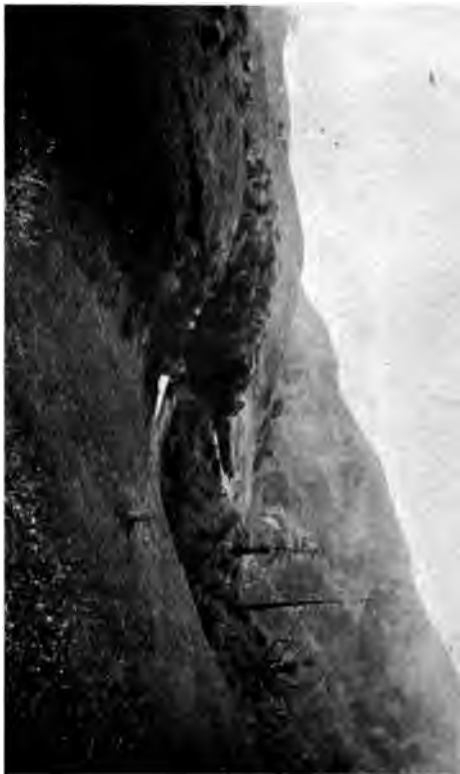
A. The Rift above Shelter Cove, looking northwest. The fault-trace follows old diastropho features. F. E. M.

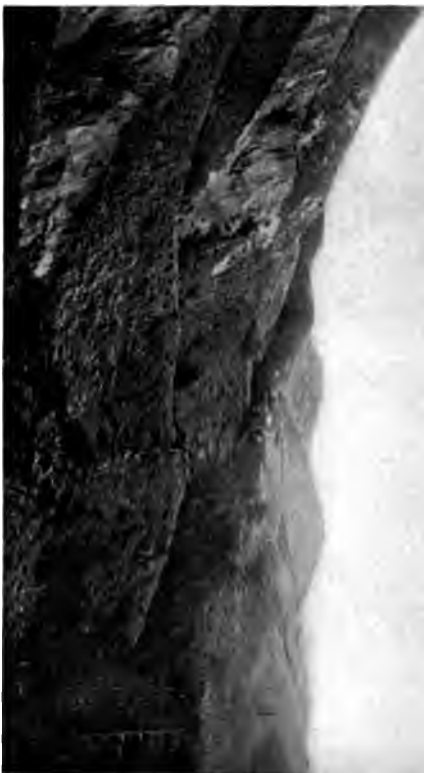
B. Northeast of Shelter Cove. Rift in the middle ground. F. E. M.

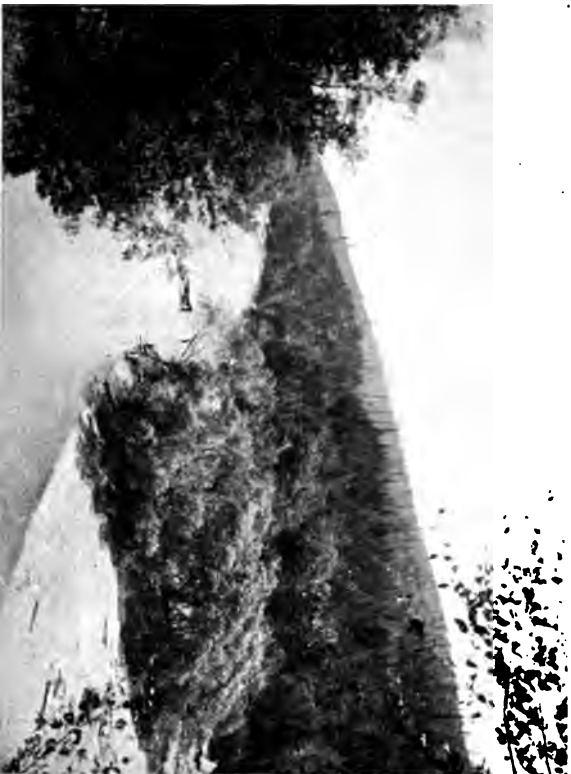
C. Looking up Garcia River along the Rift. F. E. M.

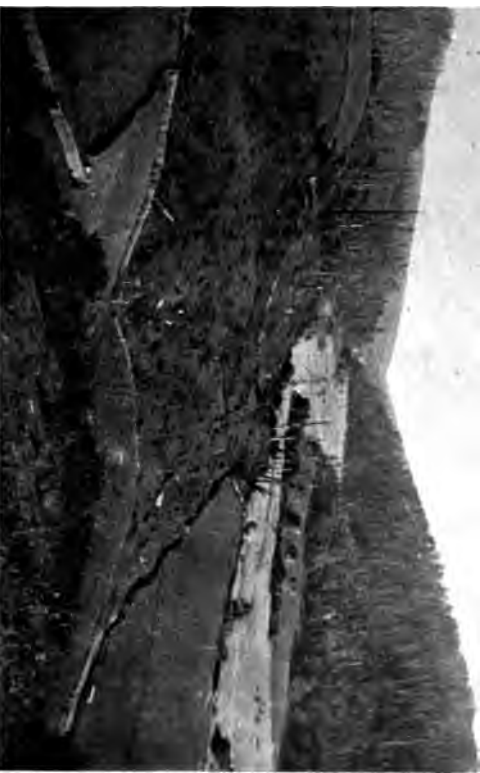
D. Looking up Garcia River along the Rift. F. E. M.

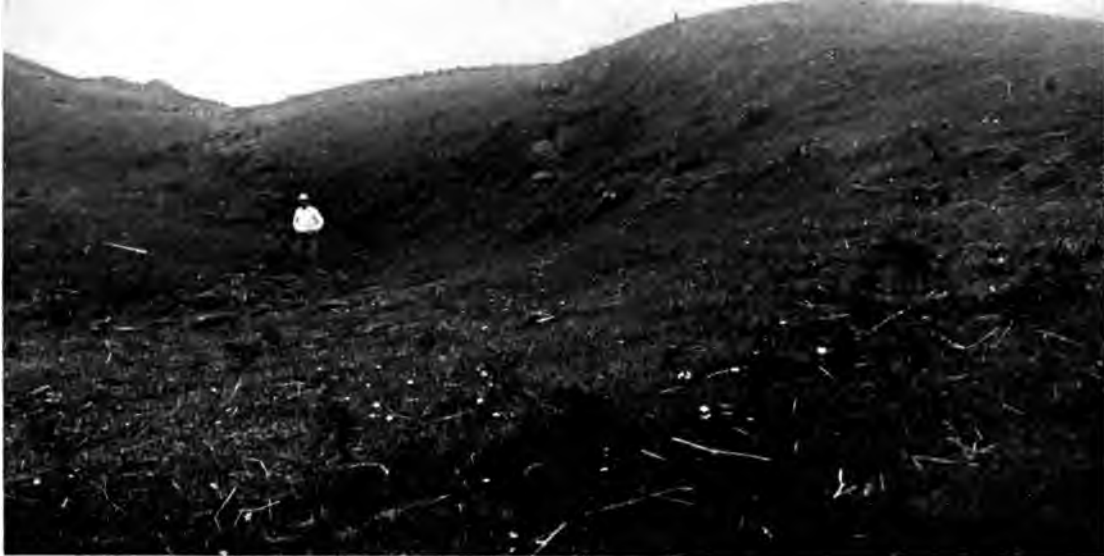
A. Characteristic Rift features southeast of Fort Ross. Figure on fault-trace. A. C. L.

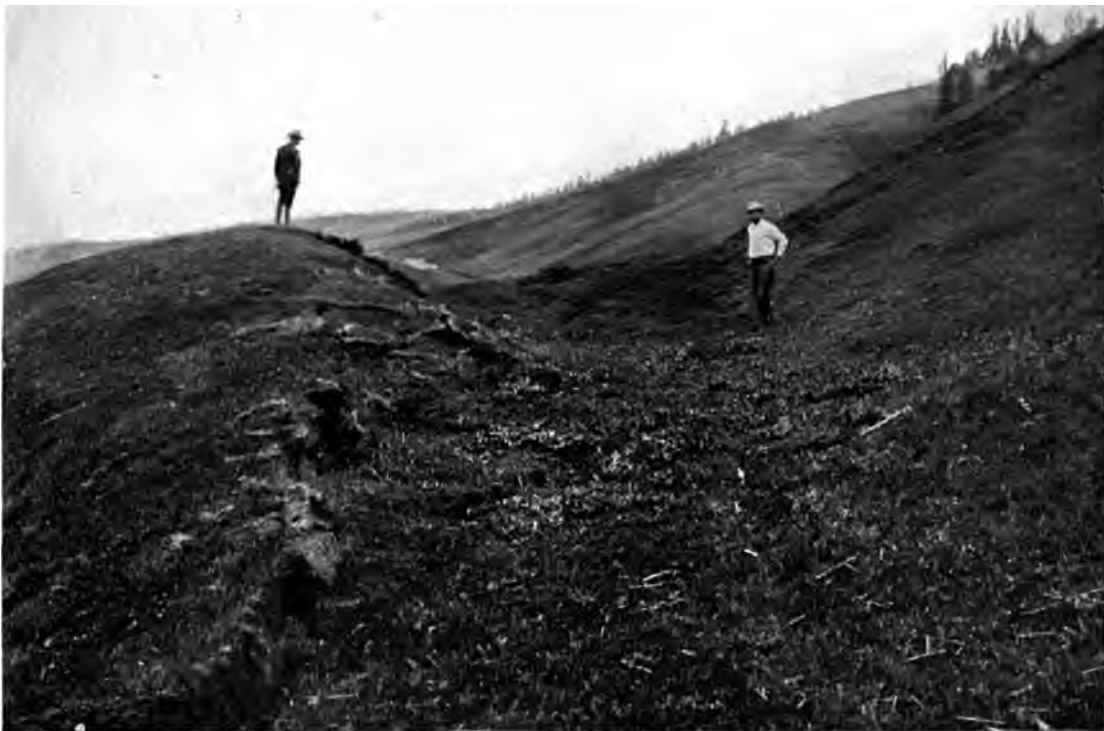
B. Characteristic Rift features southeast of Fort Ross. Fault-trace in foreground. A. C. L.

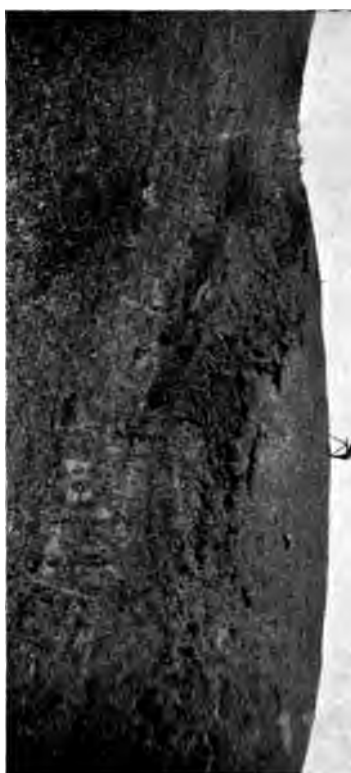
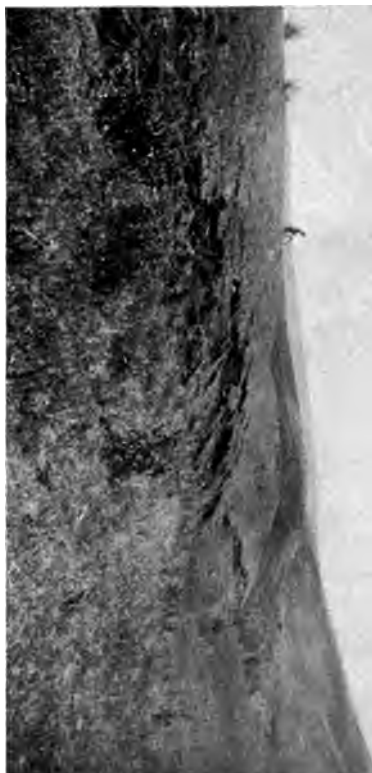
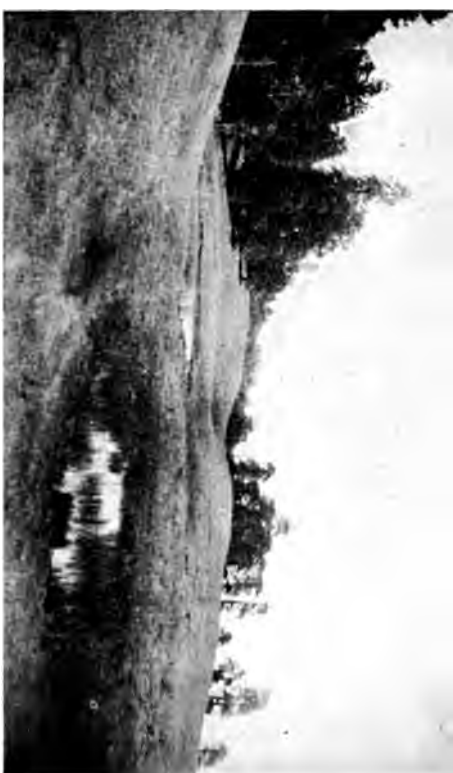
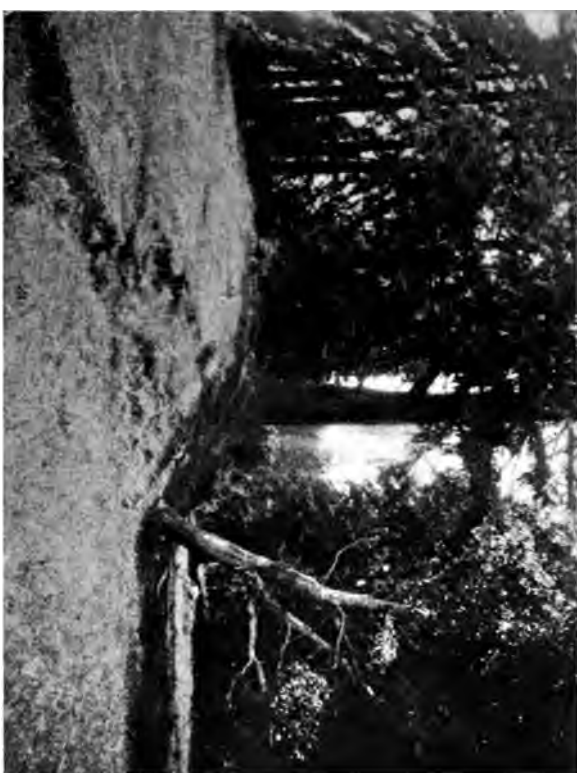
Characteristic Rift features near Fort Rose. Old scarps accentuated by new fault. Undrained ponds. F. E. M.

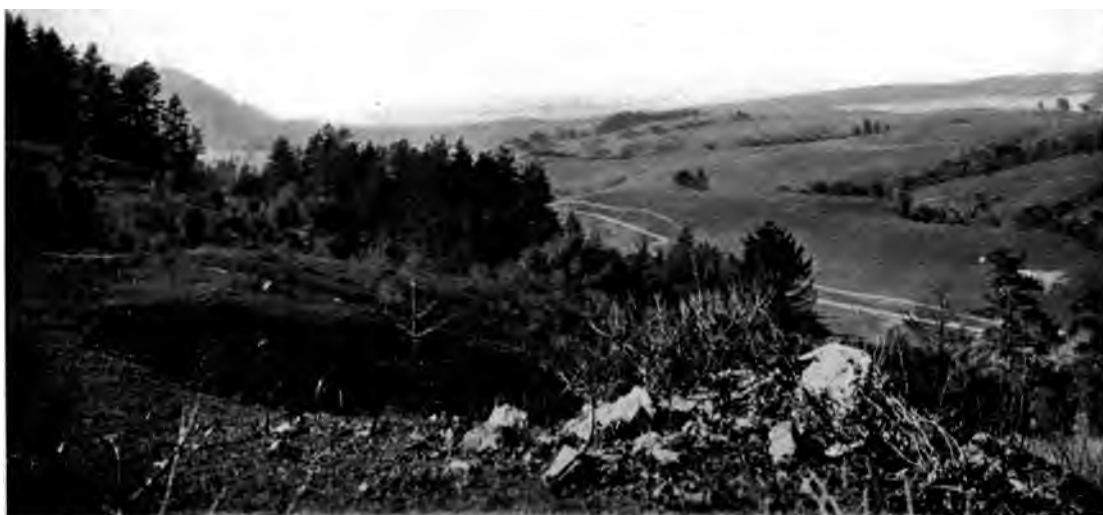
A. Looking north in the Bolinas-Tomaes Valley. G. K. G.

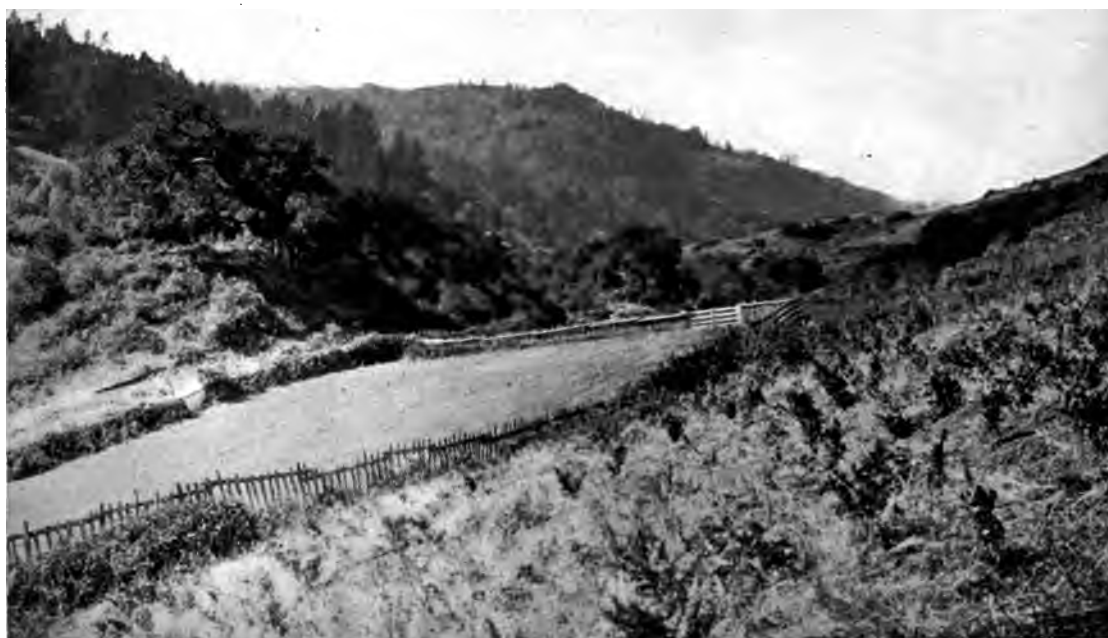
B. Fault-sag and side-hill ridge near Bondietti's ranch. The fault-trace follows sag and appears at left of field. G. K. G.

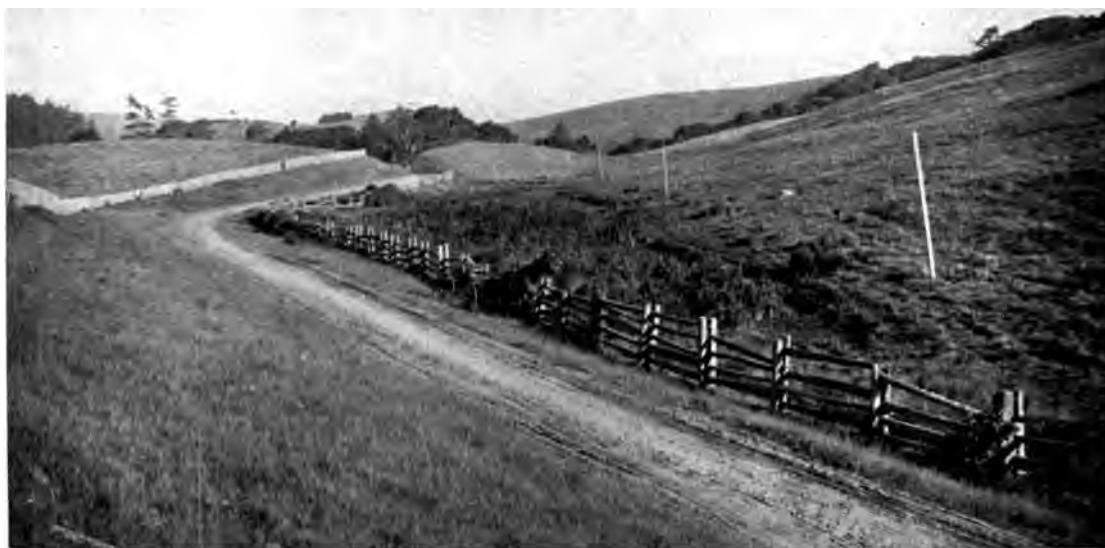
A. Fault-sag 6 miles south of Olema, looking northwest. The drainage crosses the sag from right to left. G. K. G.

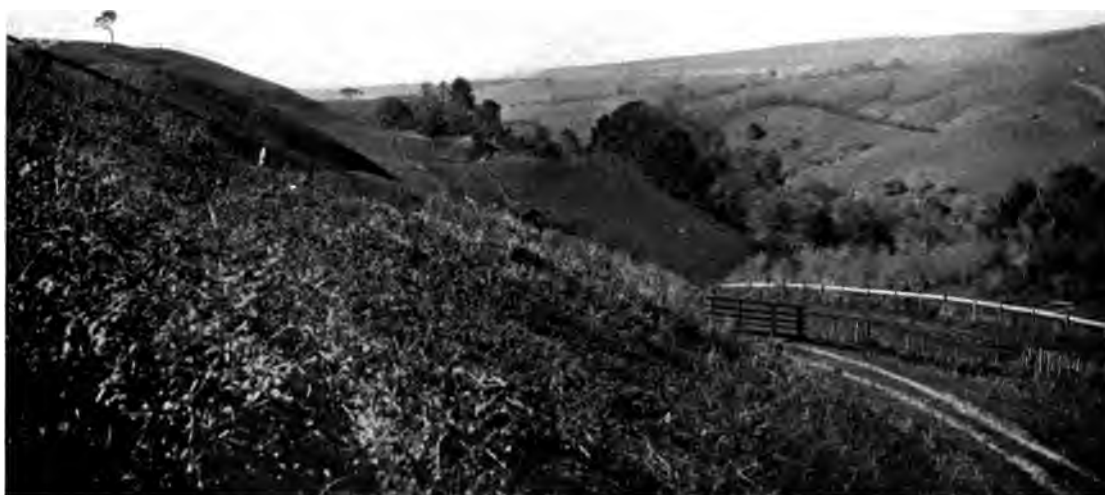
B. Side-hill ridge 4 miles south of Olema, looking northwest.

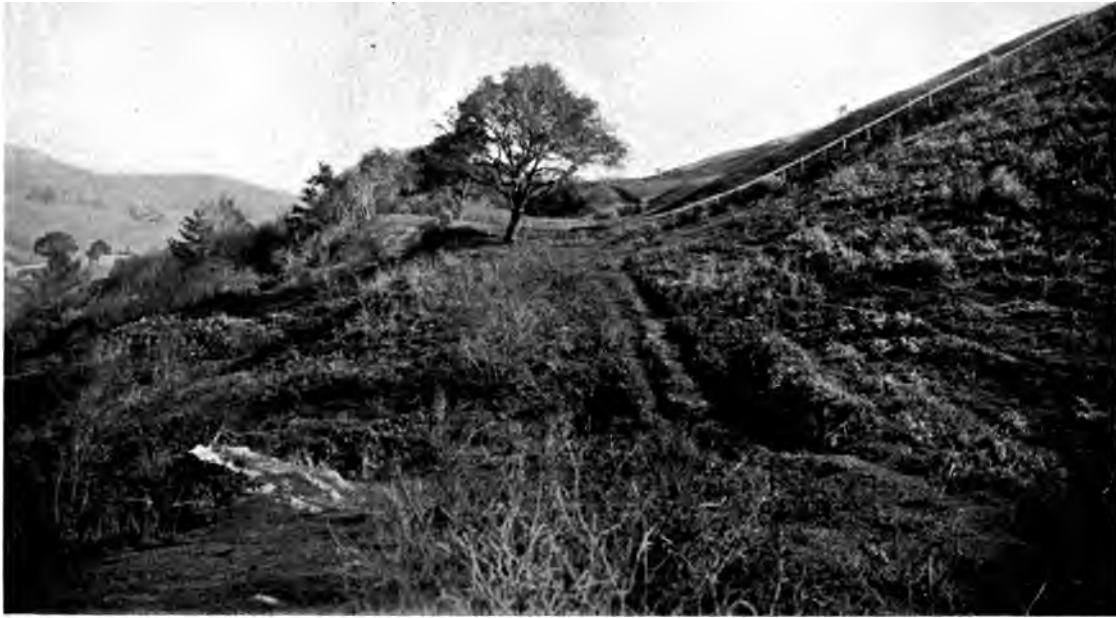
A. Side-hill ridge 4 miles south of Olema, looking southeast. G. K. G.

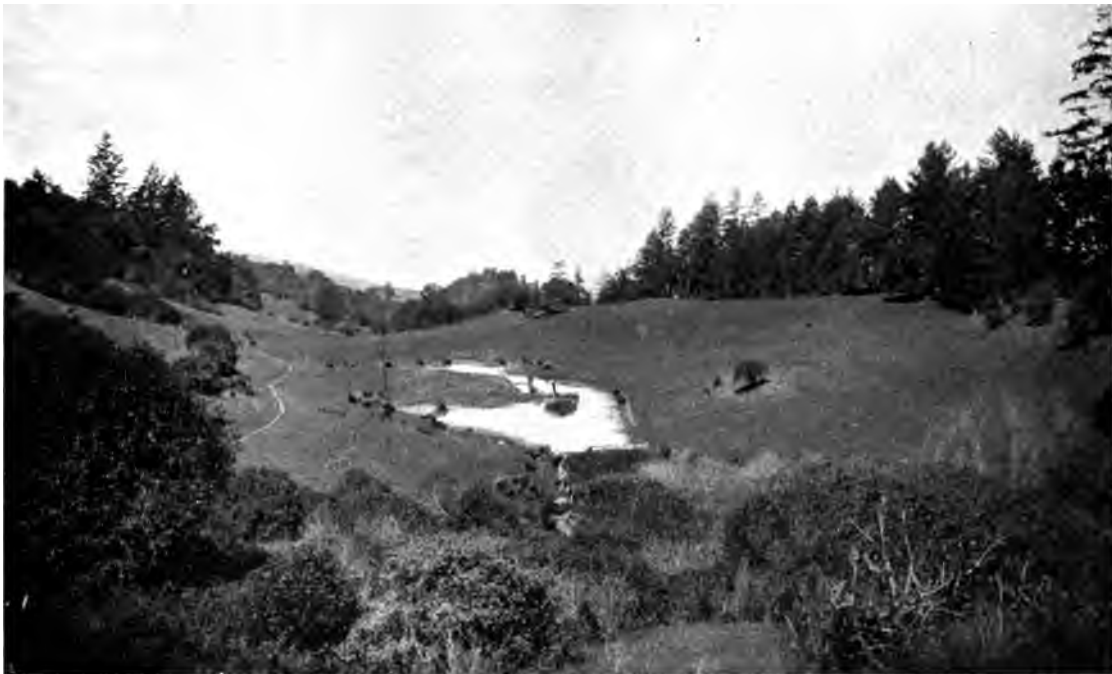
B. Rift topography, with pond, a mile south of Olema, looking southeast. G. K. G.

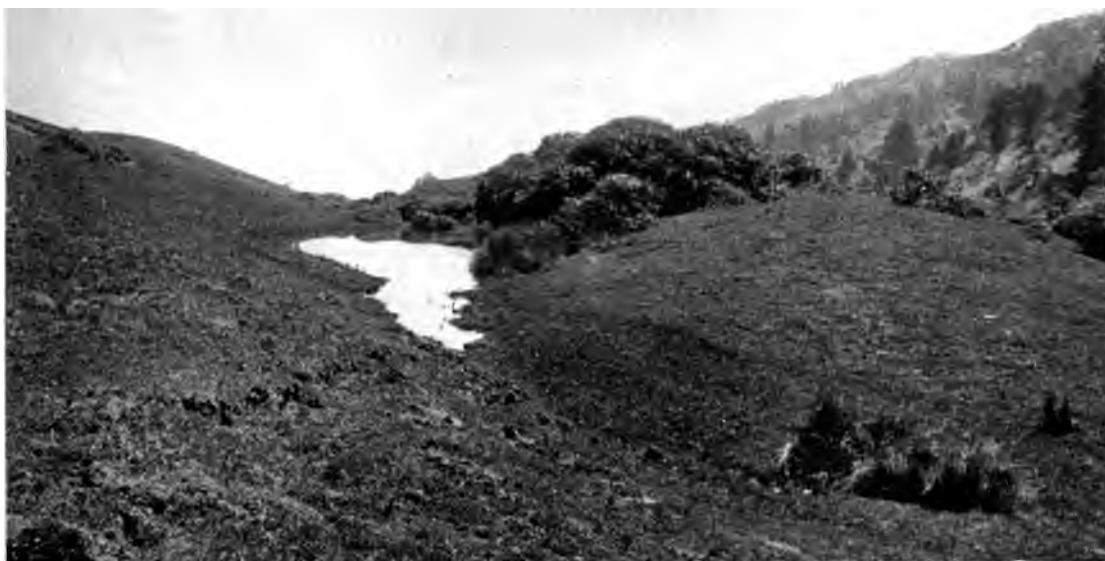
A. Rift topography, with pond, near Bondietti's ranch, looking southeast. G. K. G.

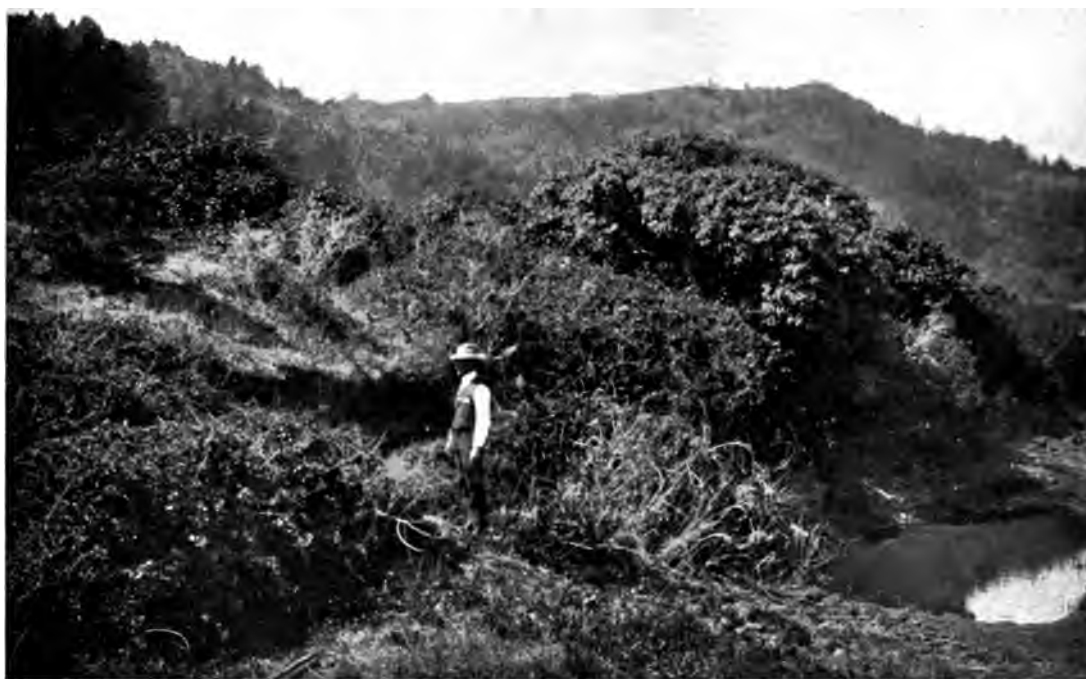
B. The fault-trace near Bondietti's ranch, looking west. Illustrates the association of vertical displacement with fault-sags and ponds. G. K. G.

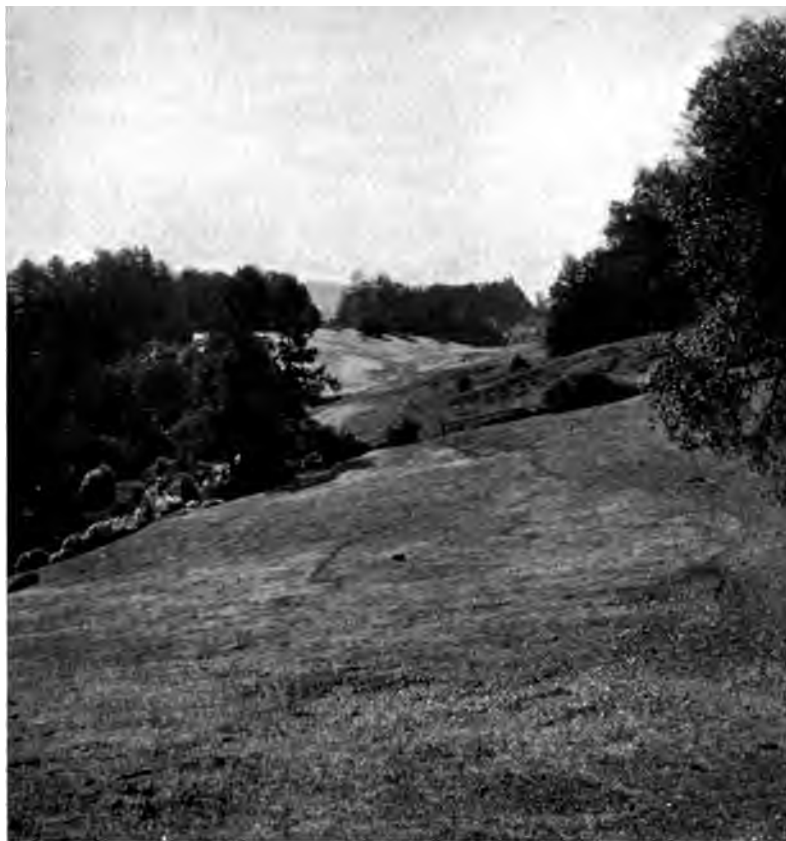
A. Fault-sag 2 miles south of Olema, looking southeast. G. K. G.

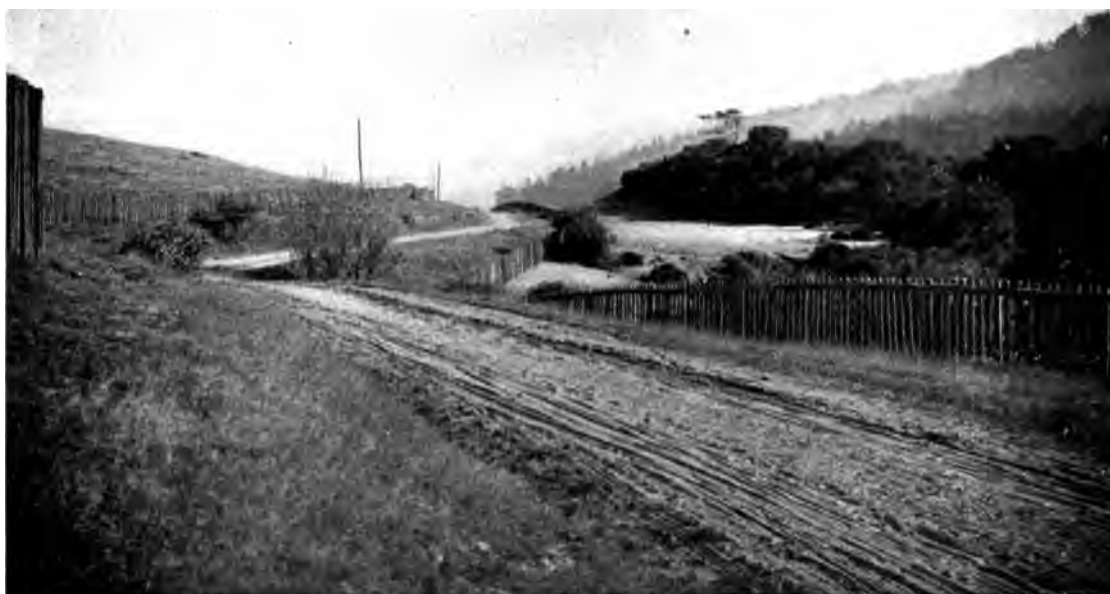
B. Fault-sag 3 miles south of Olema, looking southeast. G. K. G.

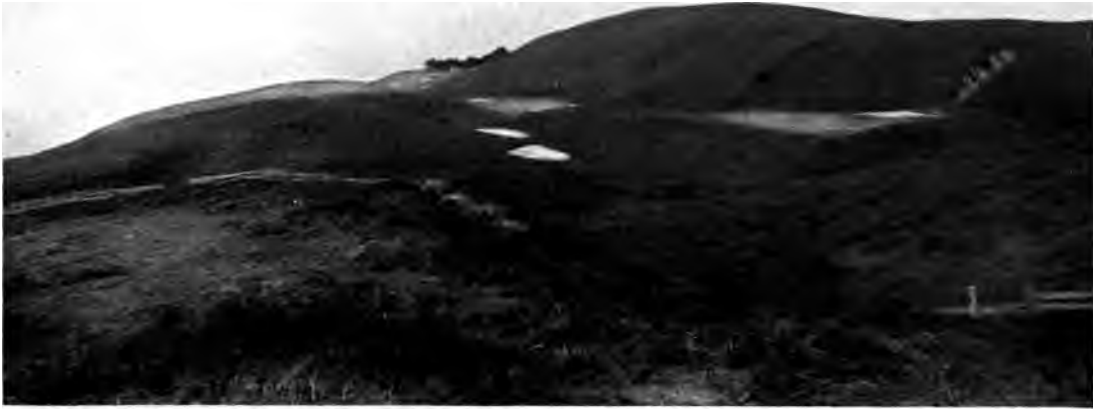
A. Great landslide at Mussel Rock, where the Rift enters the Coast from the Pacific. H. O. W.

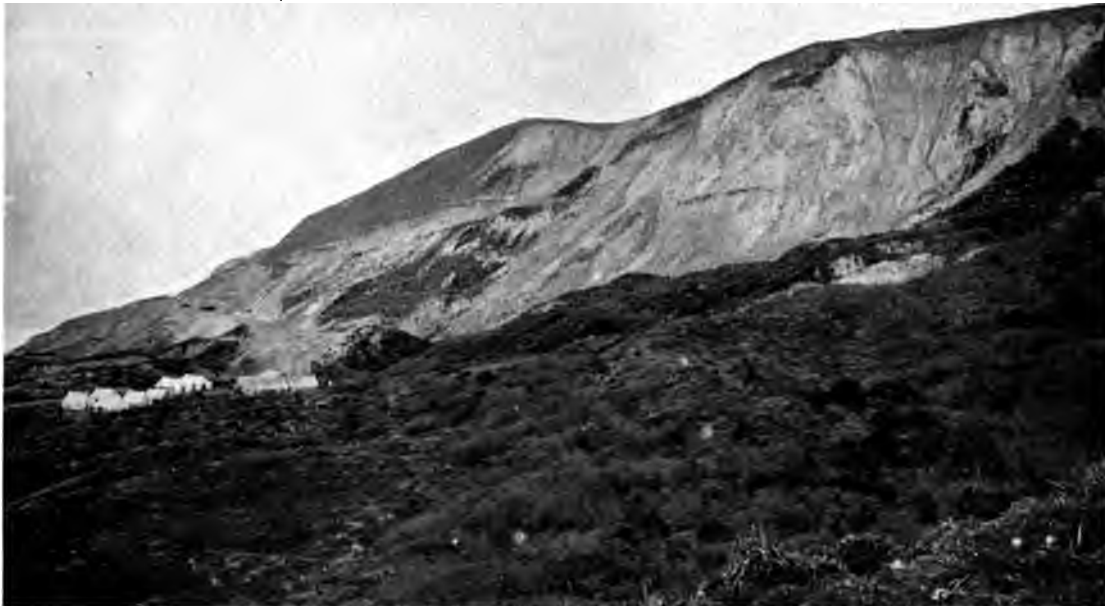
B. Looking northwest along the Rift. The landslide is just beyond the house. H. O. W.

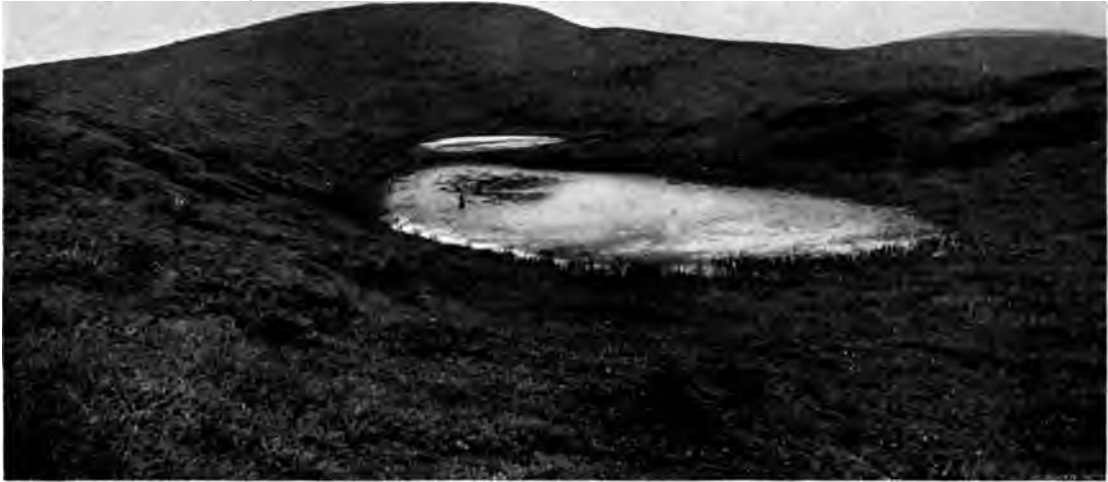
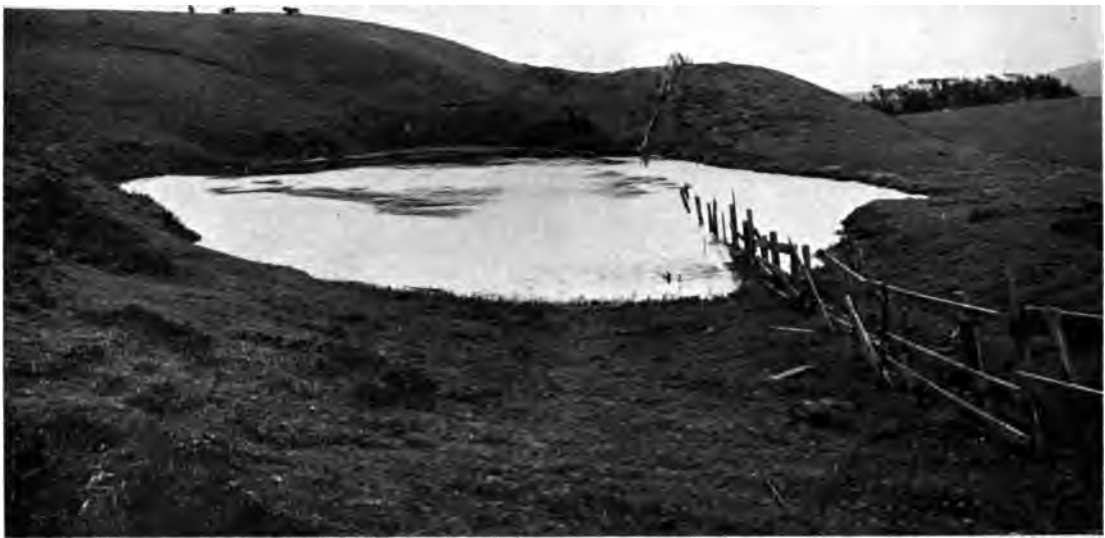
Characteristic ponds along the Rift southeast of Mussel Rock. H. O. W.

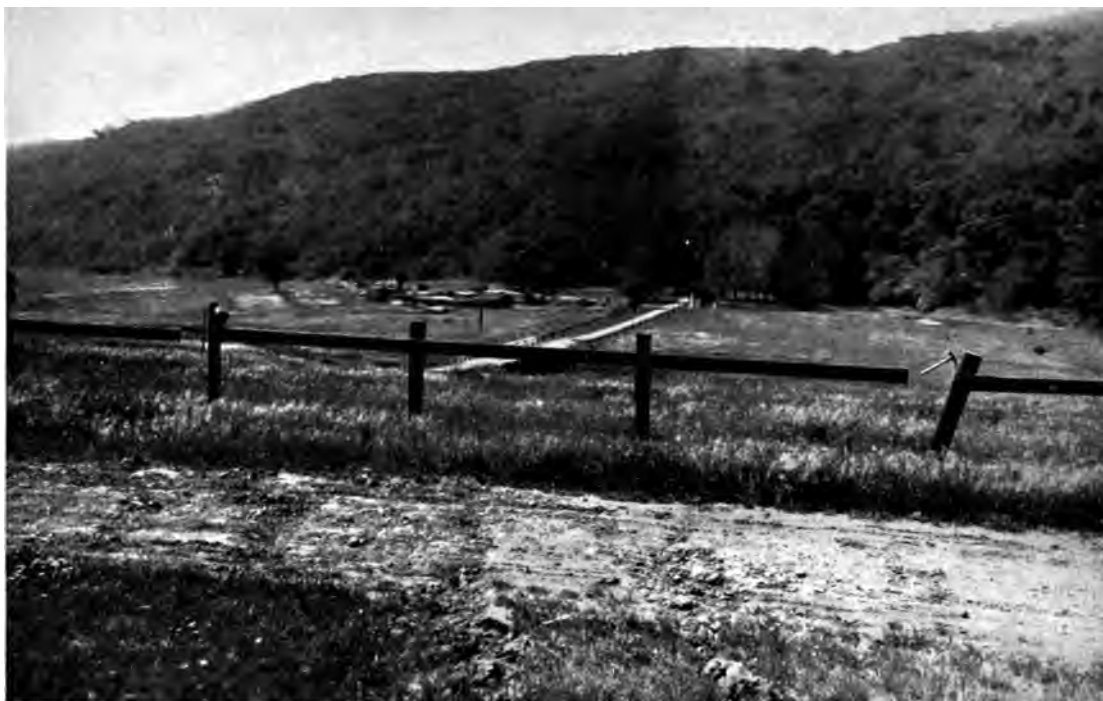
A. The Rift valley between San Andreas Lake and Crystal Springs, looking southwest. Fault-trace parallel to fence about 50 feet beyond. Auxiliary cracks in the foreground at an angle of  $40^\circ$  with it. J. C. B.

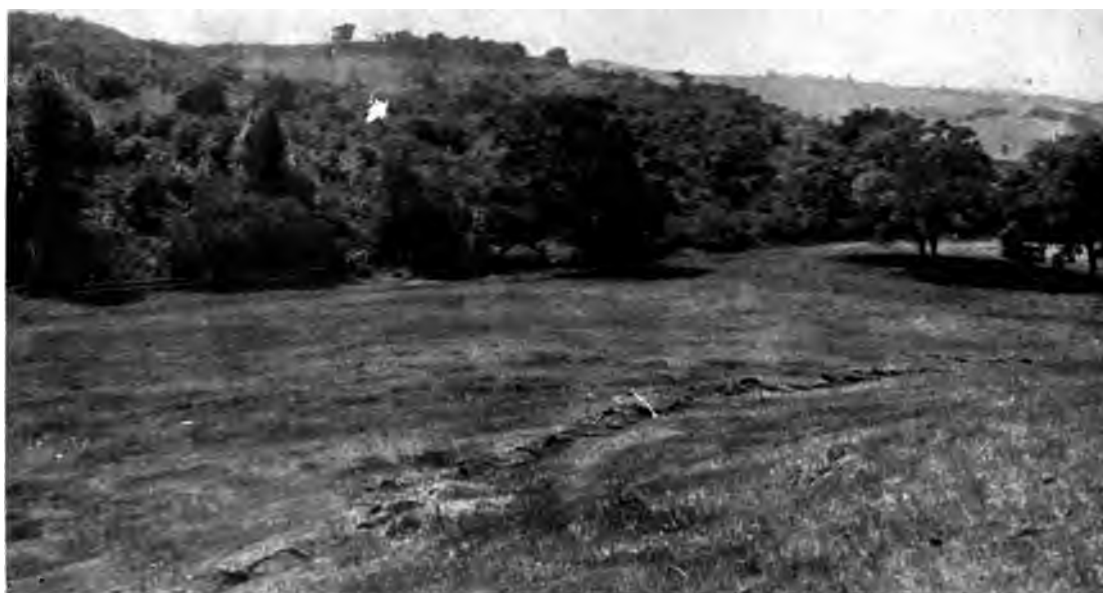
B. The Rift valley 5 miles west of Stanford University. Fault-trace in foreground. Per J. C. B.

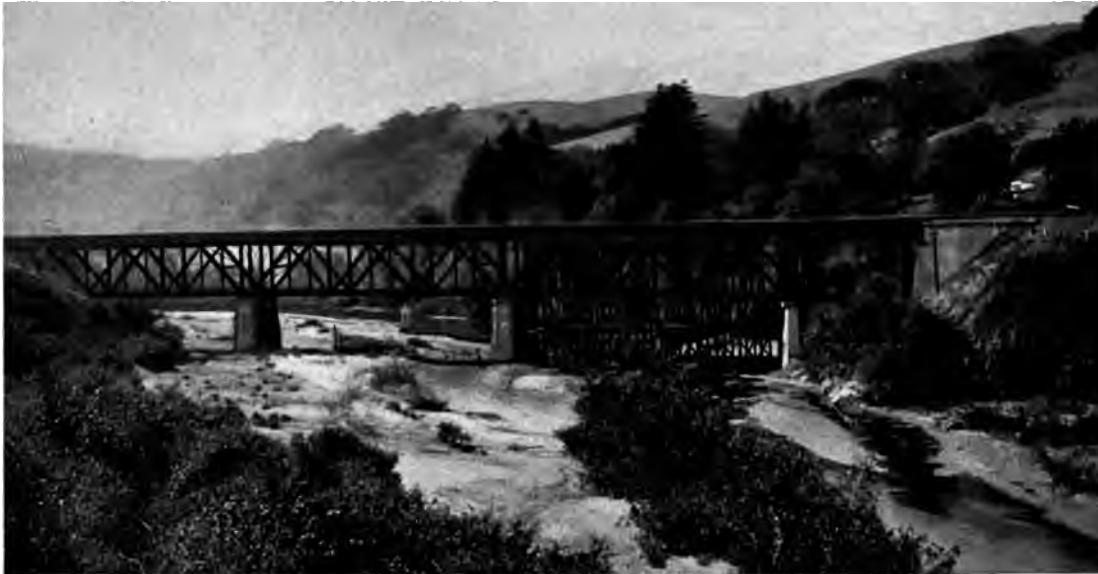
The earthquake of April 18, 1906, opened and displaced the walls of the old fault along the Rift as far south as the town of San Juan in San Benito County. The fault-trace passes directly under the western span of the Southern Pacific Railroad bridge across San Juan River, as shown by the displacement of the piers at the end of the bridge, a distance of 3.5 feet. For a distance of nearly half a mile on either side of the bridge, the river has established itself in the Rift. To the northwest the steep slopes of Mount Pajaro facing the canyon do not show any regular fissure. This does not, however, indicate any discontinuity in the fault, for the surface of the whole mountain is more or less broken by auxiliary cracks, secondary fissures, and slides.

A. The Rift followed by the Pajaro River at Chittenden. Dislocated bridge supported by false work. H.W.F.

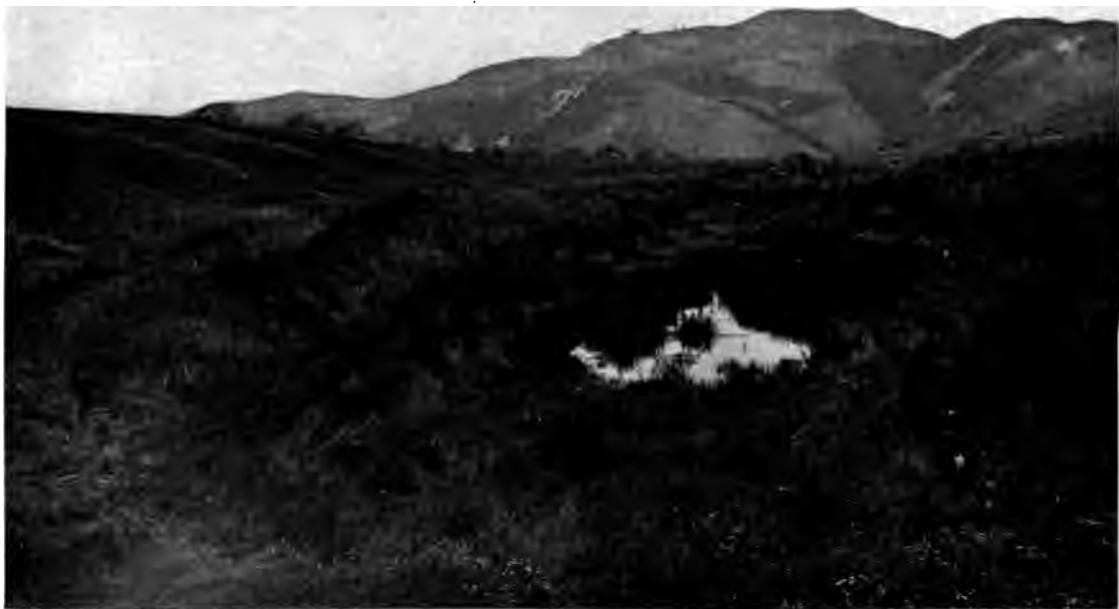
Southeast over the hills from the point where the Rift leaves the river, the characteristic features of the Rift make their appearance. It is marked by a small pond (plate 17B), springs, and a more or less continuous ridge with its steeper face toward the southwest. The fissure of the recent earthquake follows this series of features (plate 18A), and, at a point halfway between the bridge and San Juan, there is shown in a broken fence a horizontal displacement of 4 feet. A mile before reaching San Juan, granitic rocks are exposed upon the southwest side of the Rift. Shortly beyond this point the Rift leaves the hills and traverses the western edge of the valley of the San Benito River. The ridge which we have been following is now lost in the level floor of the valley, but as far as traceable its course is directly toward the low bluff upon the eastern edge of the town of San Juan. The fissure of the recent earthquake is to be seen where it crosses the road 0.5 mile northwest of San Juan, but has not been noted farther along the old Rift line. It appears to bend more easterly, and this probably connects it with the disturbances of the earth between Hollister and San Juan. Mr. Abbe, of San Juan, states that the earthquake of 1890 opened the old Rift and that the displacement of the walls, tho small, was in the same direction as in the recent earthquake.

B. The Rift a mile southeast of Chittenden. Pond on upper slope of hill. H.W.F.

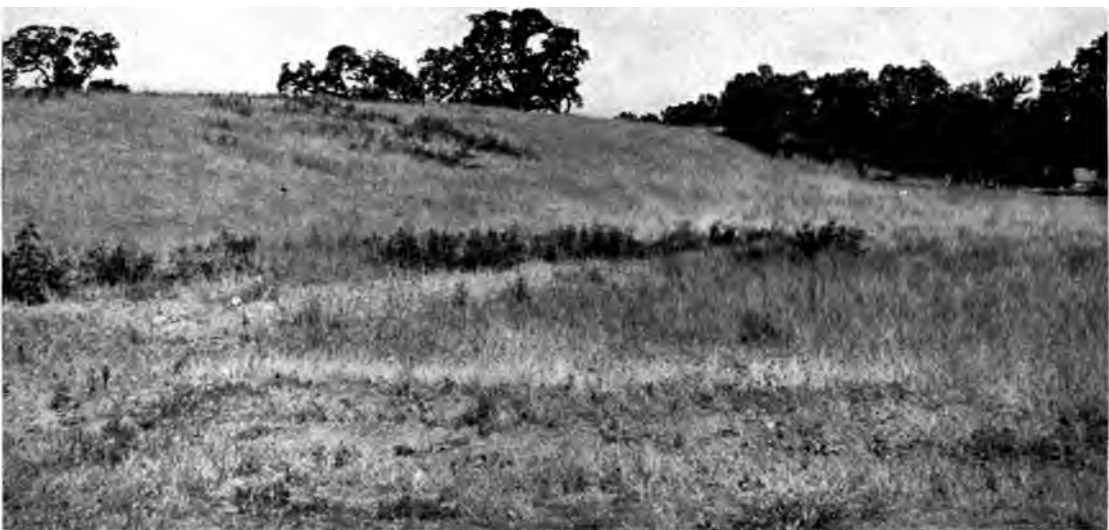
The Rift can be traced thru the hills at the head of the Cholame Valley by its characteristic features, as well as by bluffs which are undergoing rapid erosion. It crosses the road a mile west of Parkfield and exhibits here a regularly rounded ridge 200 feet wide and 20 feet high at the most elevated point. (Plate 19B.) That the ridge must be hundreds of years old is shown by the great oak trees that are growing upon it. One white oak is fully 8 feet thru. Large springs mark the fissure at this point, and are found along it the whole length of the Cholame Valley. According to a resident, the Rift opened along the ridge in the earthquake of 1901, the opening being distinctly traceable for several miles. Southeasterly from the point just described thru the Cholame Valley, there appears no very prominent ridge or escarpment, altho springs and cienegas, marking a gentle swell in the flat open surface of the valley, indicate the line of the Rift.

B. Ancient scarp on the line of the Rift a mile west of Parkfield, Cholame Valley. H. W. F.

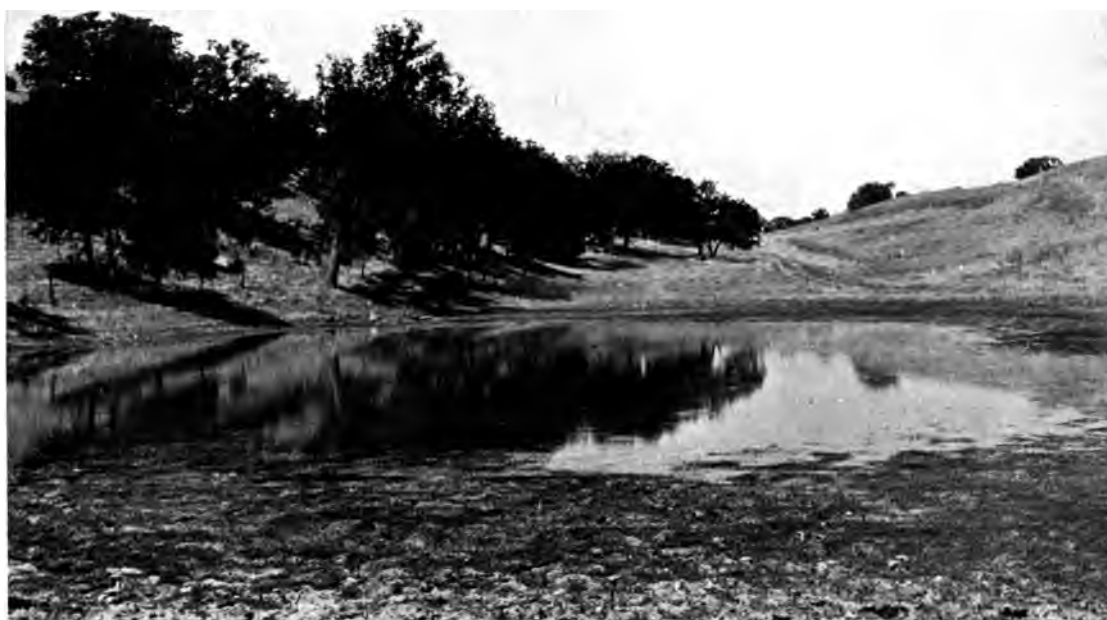
A. A branch of the Rift 2 miles southeast of Parkfield, Cholame Valley. H. W. F.

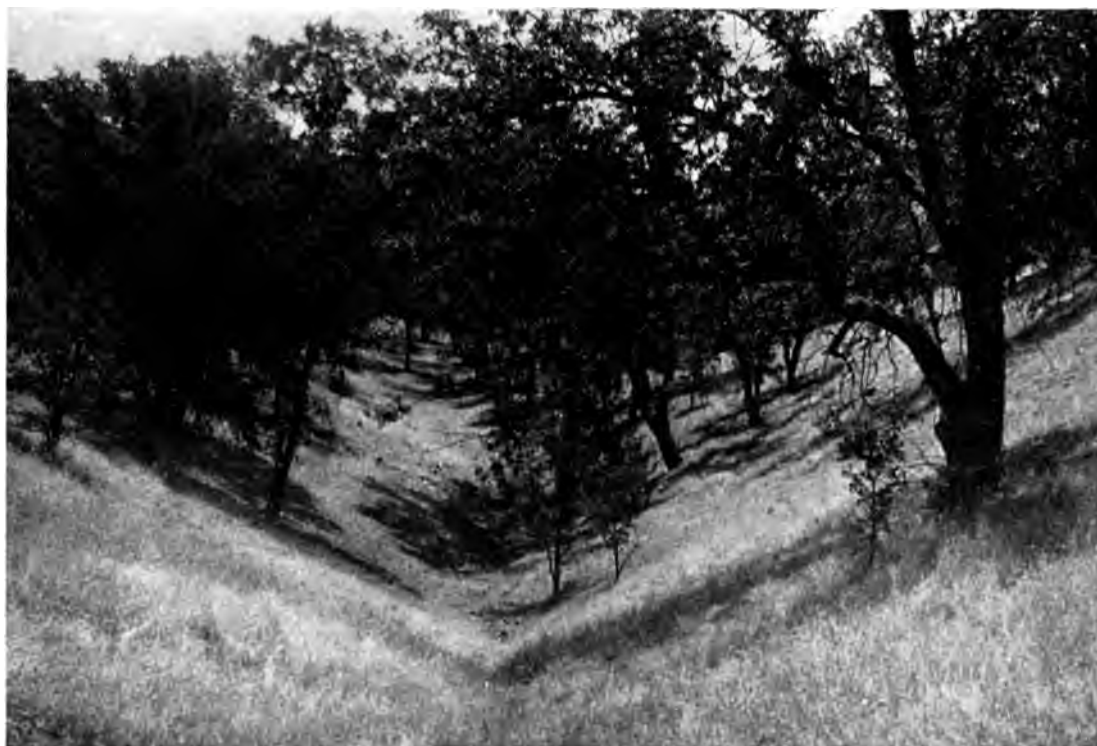
B. Another view of the same. H. W. F.

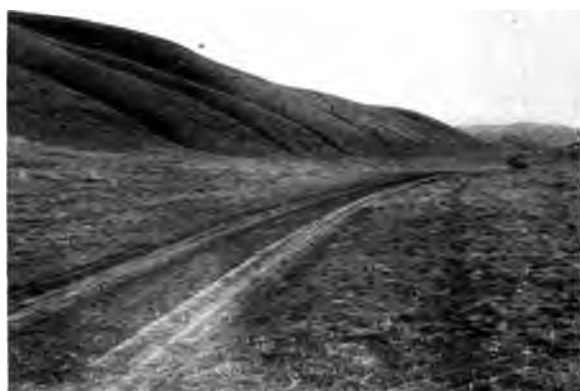
D. Rift, just beyond southeast end Carissa Plain. A. C. L., Jan., 1906.

A gentle divide separates the southern end of the Carissa Plain from a long narrow sink extending along the Rift line toward the southeast. (Plate 21D, E, F.) This sink includes an area 6 miles long and in places its drainage is fully 3 miles wide. Several depressed alkali flats, covered with water during the wet season, receive the scanty run-off of this dry region. These depressions are several hundred feet wide and are bordered upon opposite sides by quite sharp bluffs, in some places 100 feet high. The phenomena suggest the sinking of long narrow blocks between two walls. This reach of 6 miles between the ranches of Job and Emerson is one of the most interesting areas examined. The larger scarps belong to some ancient disturbance, while the last one, probably dating from 1857, is marked by features comparatively insignificant.
